# Building Inspection Report

**1212 Anywhere Lane  
Myrtle Beach**

**Inspection Date:**  
12/6/\*\*

**Report Number:**  
3400

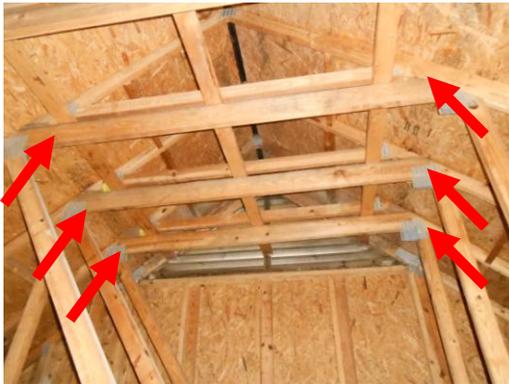
- **Repair, Monitor:** The “piggyback” trusses in the master attic do not appear to be adequately/properly secured to the lower trusses. Further evaluation and repairs, by a licensed professional, are needed.
- **Repair:** The support member running across the garage roll door openings were heavily notched to allow for the garage roll doors which significantly reduces their strength and ability to carry the weight of the home. Repairs, by a licensed professional, are needed.
- **Monitor:** Due to the design of the home, some areas of the attic were not visible and/or accessible for inspection.
- **Monitor:** Dirt debris and possible termite tubes were noted on the left side and rear foundation slab of the home. A licensed pest control company should be consulted concerning evaluation, possible treatment, a termite bond, and annual inspections of the home.

**Trusses not Strapped / Secured Properly**

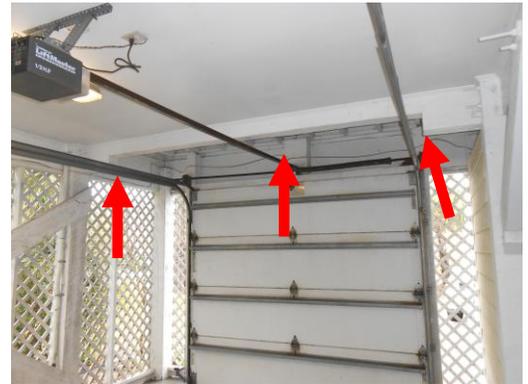
**Notched Support Member**

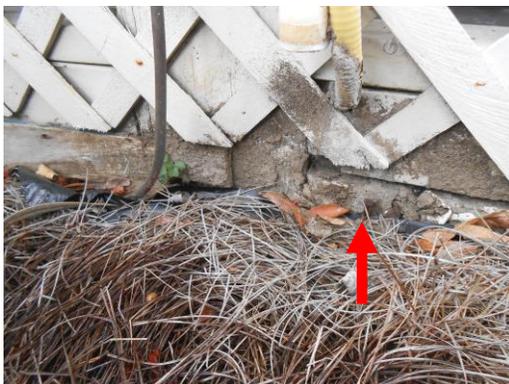
**Possible Termite Tubes – Left Side**

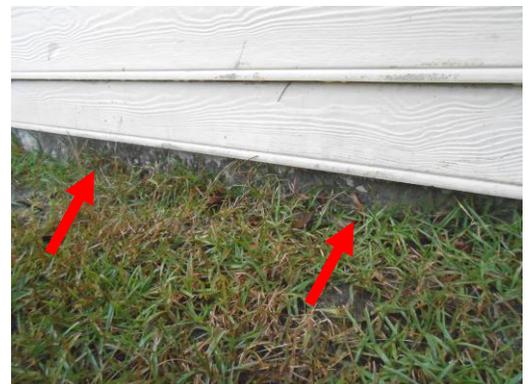
**Possible Termite Tubes – Rear**

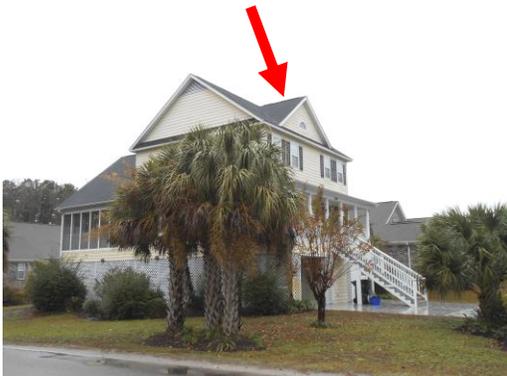
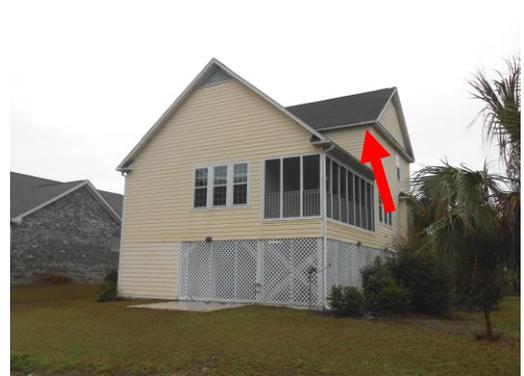
- **Repair:** A few shingles were missing at the left rear roof eave and at the front gable ridge. Repairs are needed.
- **Improve:** The gutters appear to be leaking in at least a few locations. Improvements should be made.
- **Monitor:** The gutters may require routine cleaning to avoid spilling roof runoff around the building – a potential source of water entry or water damage.

**Missing / Damaged Shingles**

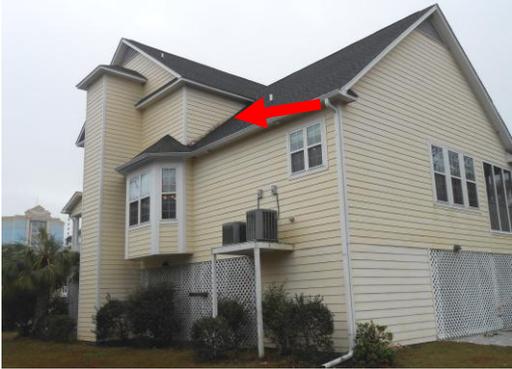
- **Improve:** The siding boards were not installed with a proper cutback (gap between the siding and the shingles). Improvements are recommended.
- **Improve:** Numerous small gaps were noted at the siding butt joints. Improvements are recommended.

**Inadequate Siding / Shingle Cutback**

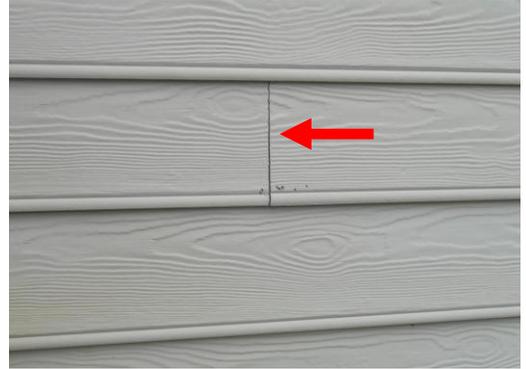
**Siding Butt Joints**

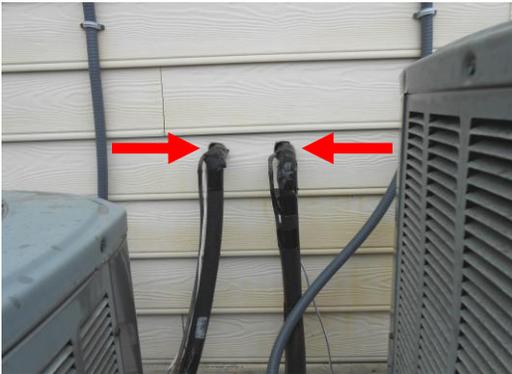
- **Repair:** The entry of the copper line sets for the heat pumps should be better sealed to help prevent possible moisture entry.
- **Improve:** The exterior siding and trim of the home require caulking/paint repairs.

**Seal Copper Line Sets Entry**

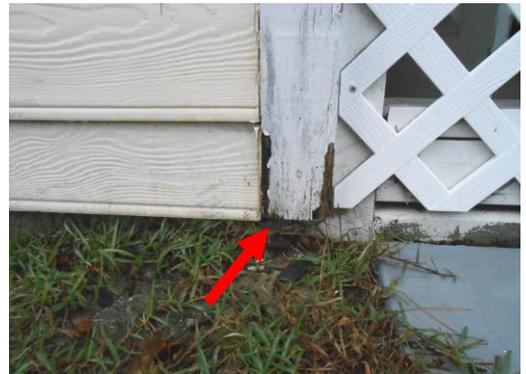
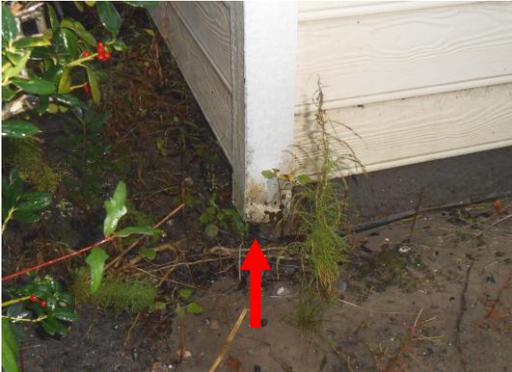
- **Repair:** The cornertrim was noted with moisture damage in a few areas. Gaps were noted between some of the corner trim boards, which can allow moisture entry. Repairs are needed.

**Damaged Corner Trim**

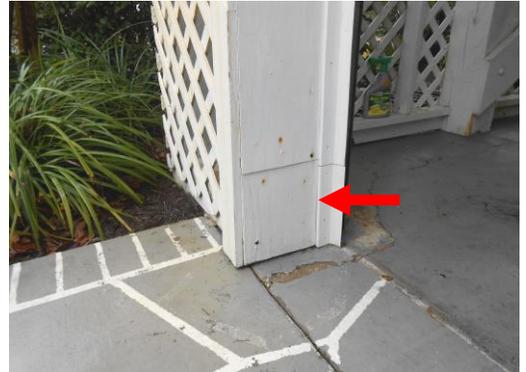
- **Repair:** The trim/frame of the garage roll door openings were noted with damage/patch repairs at the base. Further repairs are needed.
- **Improve:** The wood trim at the exterior of the garage roll doorframes was poorly installed and noted with rusted nail heads. Improvements should be made.

**Damage / Patch at Garage Roll Doorframe**

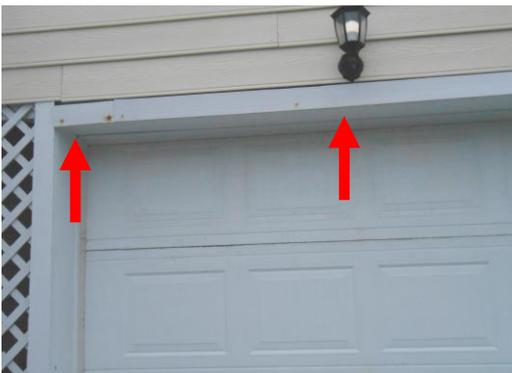
**Poorly Installed / Flashed Garage Trim**

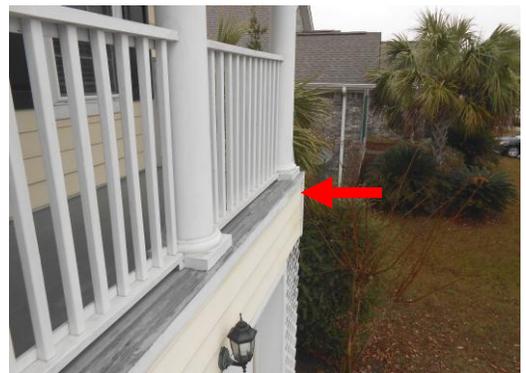
- **Repair:** The trim was loose and does not appear to be properly flashed at the edge of the front decking. Further evaluation and repairs are needed.

**Damaged / Poorly Flashed Deck**

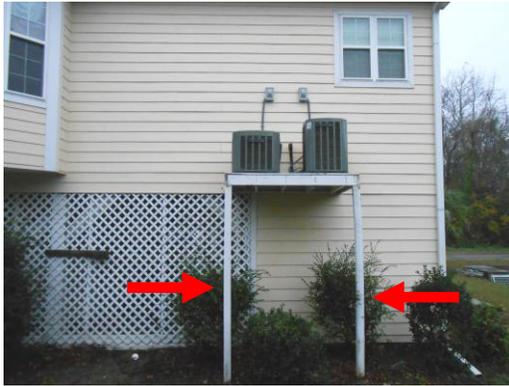
- **Repair:** The support posts for the heat pump platform were bowed and require additional support/bracing.
- **Repair:** The exterior stair treads were noted with some deterioration and peeling paint. A few treads will likely require replacement, while the others require caulking/paint repairs.

**Bowed Supports**

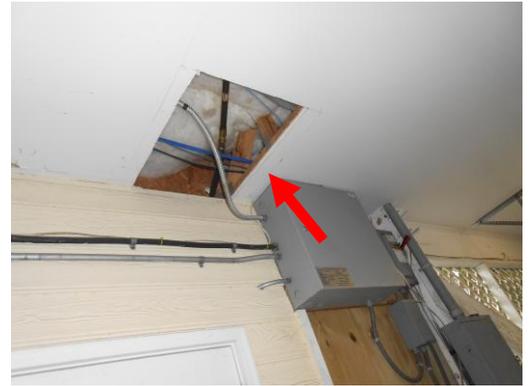
**Opening in Garage Ceiling**

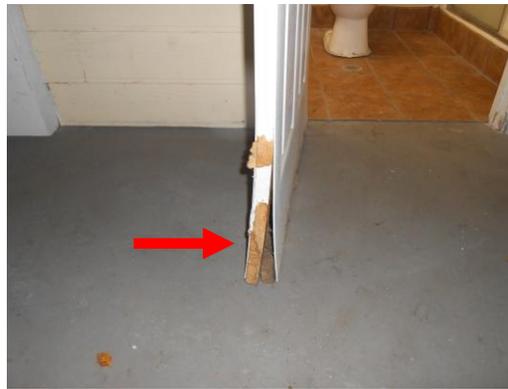
- **Repair:** The closet/bathroom doors beneath the home were noted with moisture damage and deterioration. Replacement is needed.
- **Improve:** An opening was noted in the ceiling of the right side garage. Improvements should be made.

**Damaged Garage Closets / Bathroom Doors**

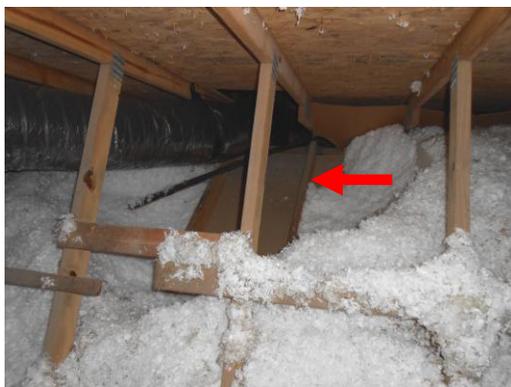
**Missing Insulation in Top Floor Attic**

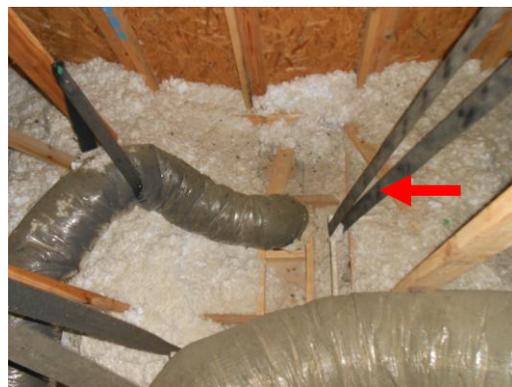
**Displaced Insulation in Master Attic**

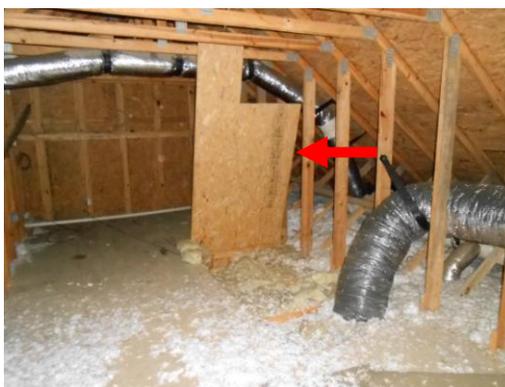
**Attic Floor Sheathing Pulled Up**

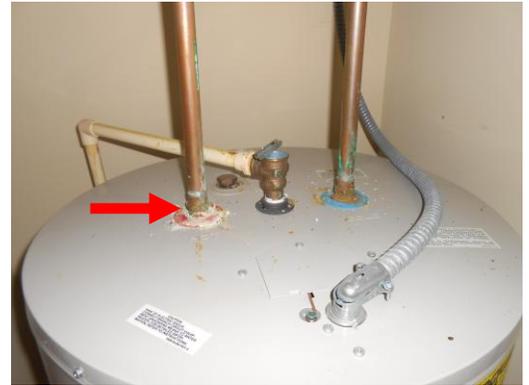
- **Monitor:** The water heater was approximately thirteen years old and was noted with some rust/corrosion at the supply connection. It is likely at the end of its useful life. The average lifespan of a water heater is ten years. Expect to replace the tank in the near future.

**Corrosion at Water Heater Supply**

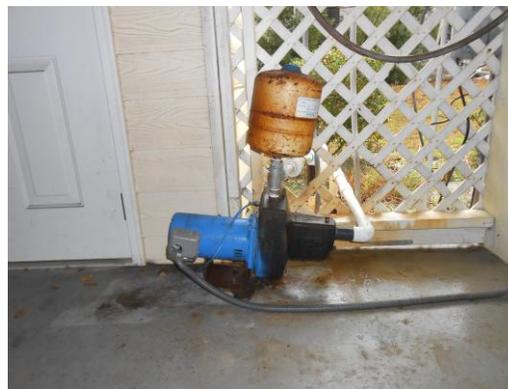
- **Improve:** We recommend caulking between the sink tops and the sidesplashes in the master bathroom to help prevent possible moisture penetration.
- **Improve:** The irrigation well pump was noted with heavy rust/corrosion and the base appears to be bent/damaged.

**Irrigation Well Pump**

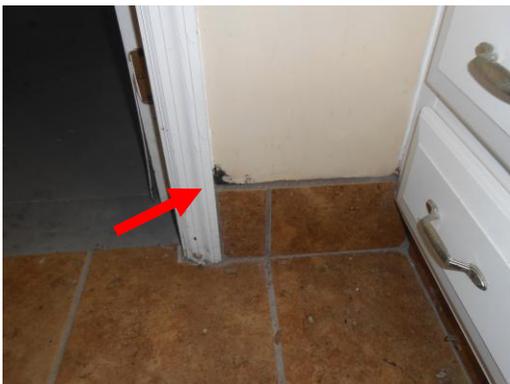
- **Repair, Monitor:** Mildew/mold growth was noted on the wall inside the garage bathroom. Further evaluation and repairs are needed.
- **Improve:** Mildew was noted on many of the surfaces beneath the home. A thorough cleaning is needed.

**Mold on Garage Bathroom Wall**

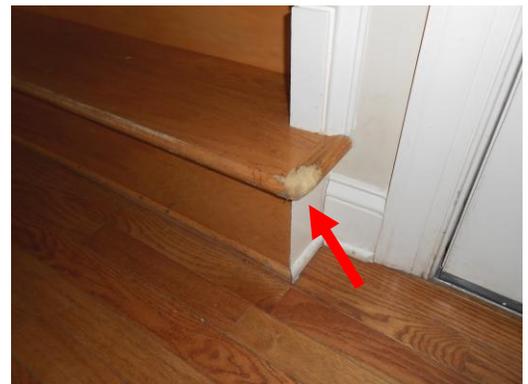
**Damaged Stair Tread**

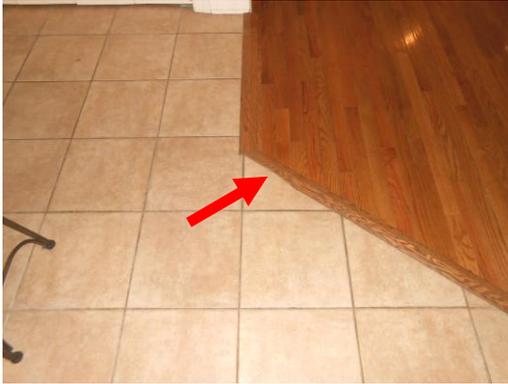
- **Improve:** The wood flooring was noted with numerous scratches as well as some minor cupping. Cosmetic improvements may be desired.
- **Repair:** The wooden transition piece between the living room and the kitchen was damaged and requires replacement.

**Damaged Wooden Transition**

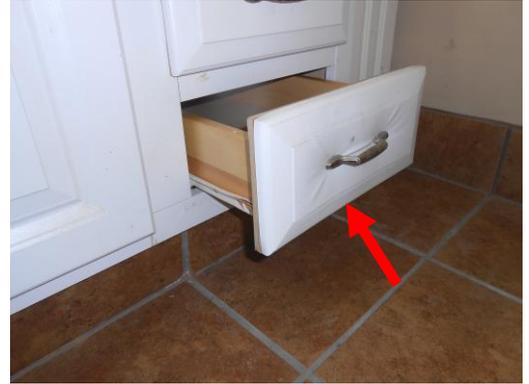
- **Repair:** The cabinets in the garage bathroom were damaged by moisture and require repair/replacement.
- **Improve:** The small bumpers for the kitchen cabinet doors/drawers were deteriorated and have become sticky. Replacement is needed.

**Damaged Garage Bathroom Vanity Cabinets**
